Flood Control Project Maintenance
Levee Inspections

Fall 2013 Levee Maintenance Deficiency Summary Report

Sacramento River Basin

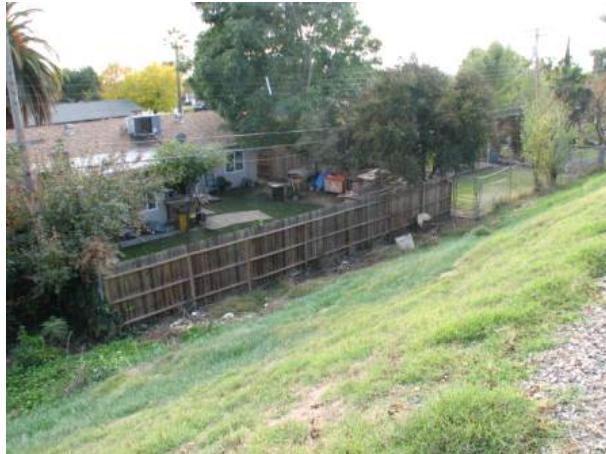
Levee Mile Report Line	7
Start Levee Mile	0.77
End Levee Mile	0.77
Location	Land Side
Category	Earthen Levee
Item	Encroachments
11/17/2011 Wooden privacy fence.	
mkhashch_f_20130923_861.jpg

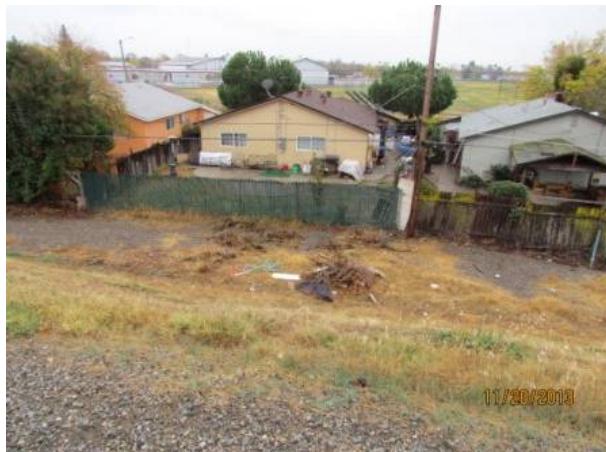
Levee Mile Report Line	8
Start Levee Mile	0.80
End Levee Mile	0.80
Location	Land Side
Category	Earthen Levee
Item	Encroachments
View of the debris at the landside levee toe.	
mkhashch_f_20131120_741.JPG

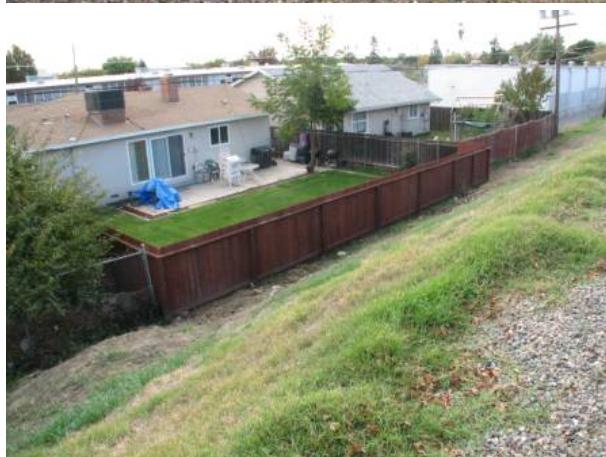
Levee Mile Report Line	9
Start Levee Mile	0.95
End Levee Mile	0.95
Location	Land Side
Category	Earthen Levee
Item	Encroachments
11/17/2011 Wooden privacy fence built at the levee toe.	
mkhashch_f_20130923_860.jpg

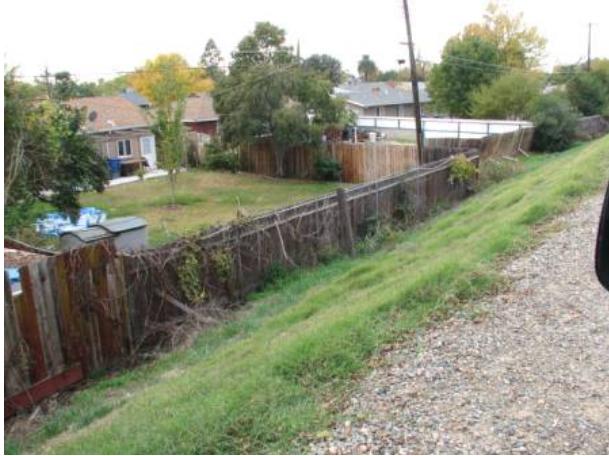
Levee Mile Report Line	11
Start Levee Mile	1.16
End Levee Mile	1.16
Location	Land Side
Category	Earthen Levee
Item	Encroachments
11/17/2011 Fence built on the levee slope.	
mkhashch_f_20130923_836.jpg

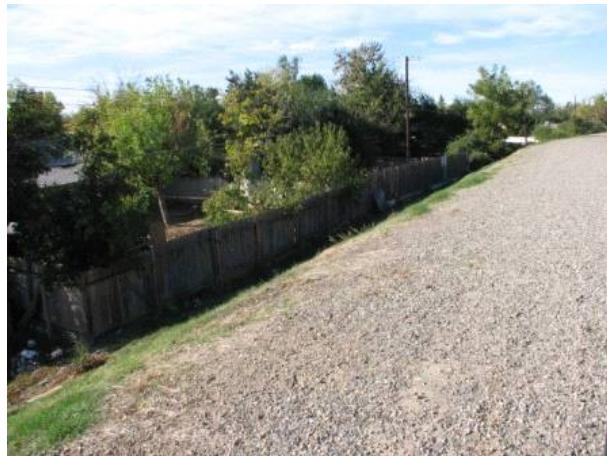
mkhashch_f_20130923_833.jpg

Photo of solid fences built against the levee slope.

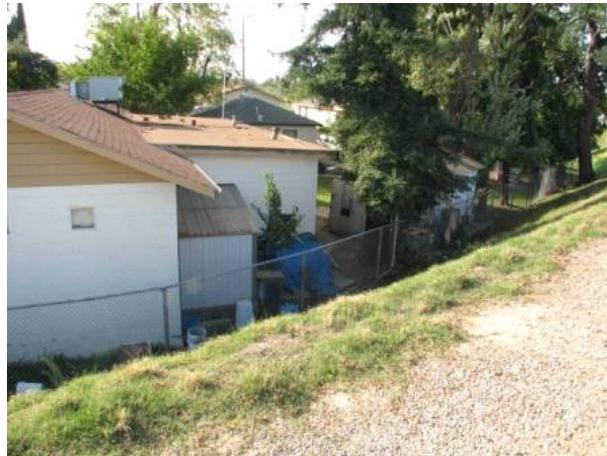
mkhashch_f_20130923_832.jpg

Levee Mile Report Line	15
Start Levee Mile	1.26
End Levee Mile	1.26
Location	Land Side
Category	Earthen Levee
Item	Encroachments

Fall 2009 photo: Buildings and fence near levee toe.

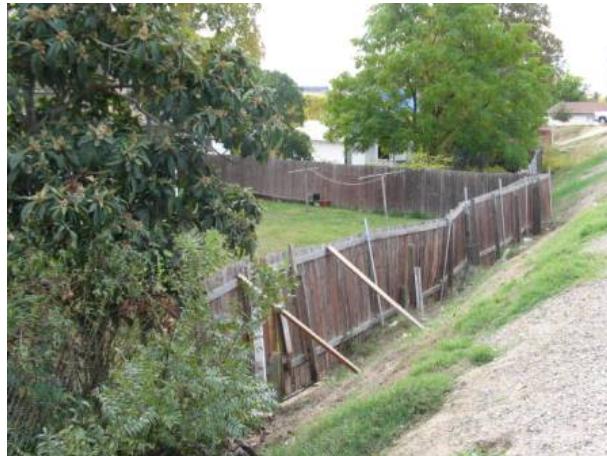
mkhashch_f_20130923_831.jpg

Levee Mile Report Line	17
Start Levee Mile	1.35
End Levee Mile	1.35
Location	Land Side
Category	Earthen Levee
Item	Encroachments

11/17/2011 Wooden privacy fence built at the levee toe. Levee slope is being used to support the fence.

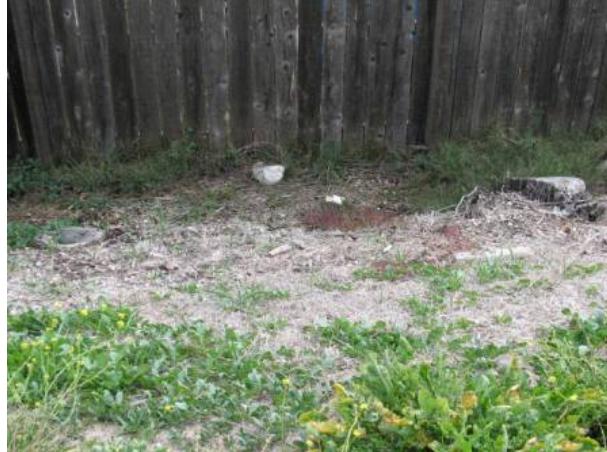
Levee Mile Report Line	18
Start Levee Mile	1.35
End Levee Mile	1.35
Location	Land Side
Category	Earthen Levee
Item	Trim / Thin Trees
11/17/2011 Two stumps at levee toe.	
mkhashch_f_20130923_859.jpg

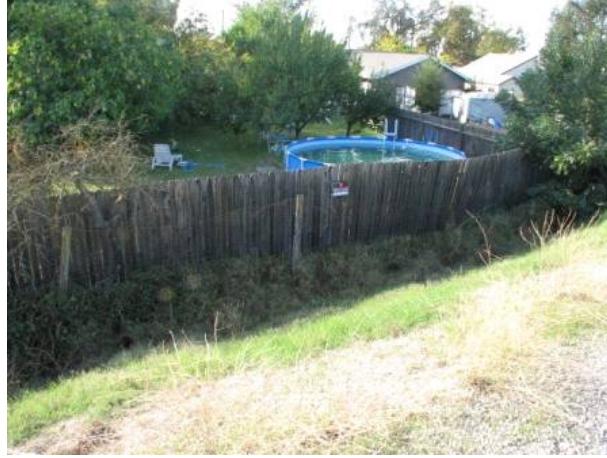
Levee Mile Report Line	20
Start Levee Mile	1.38
End Levee Mile	1.38
Location	Land Side
Category	Earthen Levee
Item	Encroachments
Fall 2009 photo: Wooden and wire fence are within 10-ft of levee toe.	
mkhashch_f_20130923_829.jpg

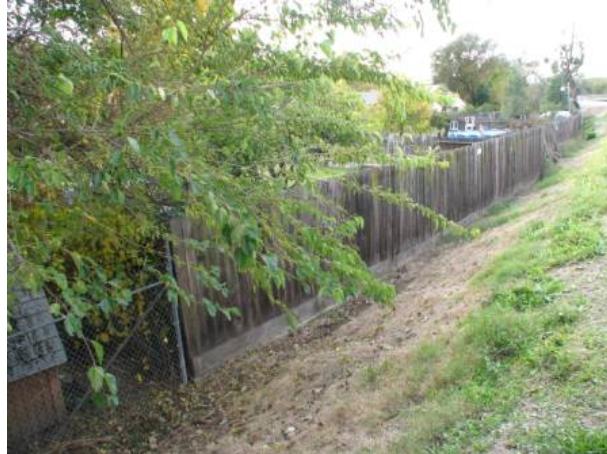
Levee Mile Report Line	21
Start Levee Mile	1.39
End Levee Mile	1.39
Location	Land Side
Category	Earthen Levee
Item	Encroachments
11/17/2011 Wooden privacy fence built at the levee toe.	
mkhashch_f_20130923_828.jpg

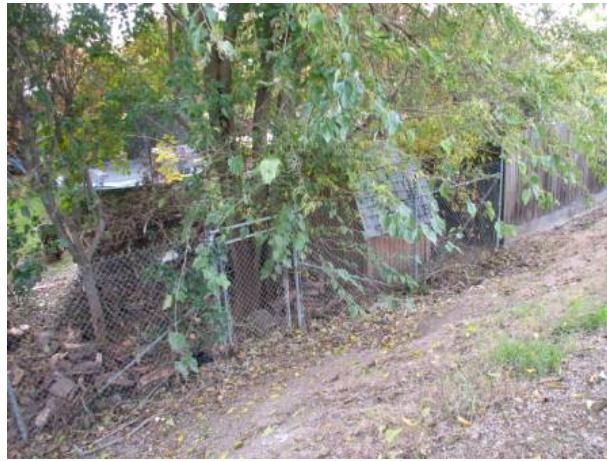
Levee Mile Report Line	22
Start Levee Mile	1.40
End Levee Mile	1.40
Location	Land Side
Category	Earthen Levee
Item	Encroachments
11/17/2011 Shed and firewood can be seen through the chainlink fence.	
mkhashch_f_20130923_845.jpg

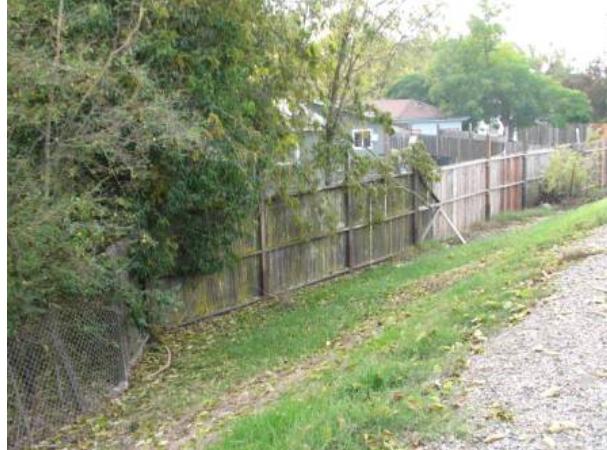
Levee Mile Report Line	24
Start Levee Mile	1.42
End Levee Mile	1.42
Location	Land Side
Category	Earthen Levee
Item	Encroachments
11/17/2011 Wooden privacy fence built within 15' of the levee toe.	
mhashch_f_20130923_826.jpg

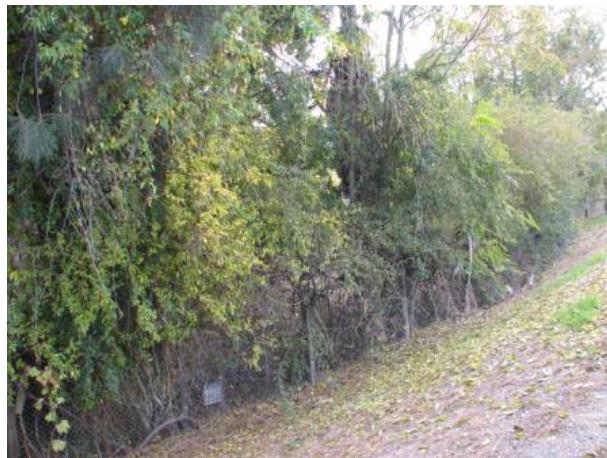
Levee Mile Report Line	25
Start Levee Mile	1.43
End Levee Mile	1.43
Location	Land Side
Category	Earthen Levee
Item	Vegetation
11/17/2011 Thick vegetation at the levee toe.	
mhashch_f_20130923_858.jpg

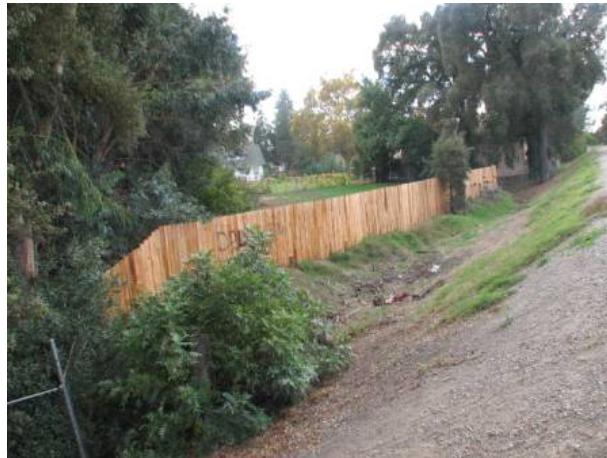
Levee Mile Report Line	26
Start Levee Mile	1.48
End Levee Mile	1.48
Location	Land Side
Category	Earthen Levee
Item	Encroachments
11/17/2011 Wooden privacy fence built within 15' of the levee toe.	
mhashch_f_20130923_857.jpg

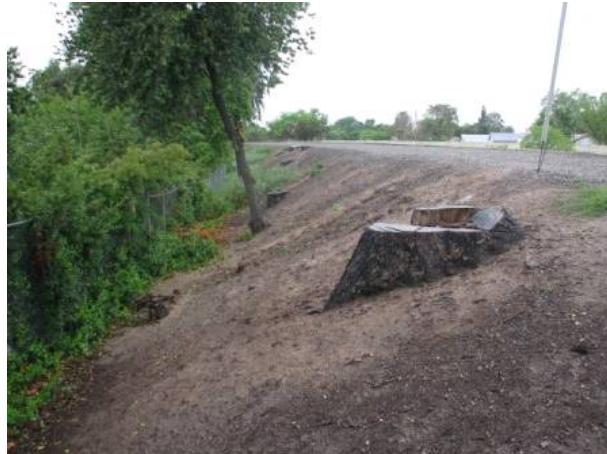
Levee Mile Report Line	27
Start Levee Mile	1.52
End Levee Mile	1.52
Location	Land Side
Category	Earthen Levee
Item	Trim / Thin Trees
Several large stumps on levee slope.	
mkhashch_f_20130923_847.jpg

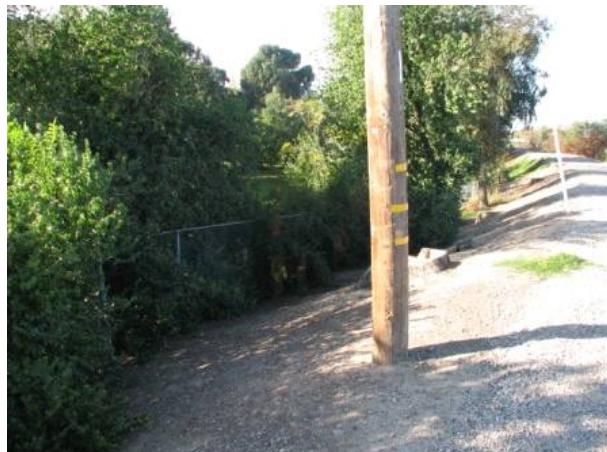
Levee Mile Report Line	28
Start Levee Mile	1.54
End Levee Mile	1.54
Location	Land Side
Category	Earthen Levee
Item	Vegetation
Fall 2009 photo: Vegetation obstructing visibility near levee slope.	
mkhashch_f_20130923_843.jpg

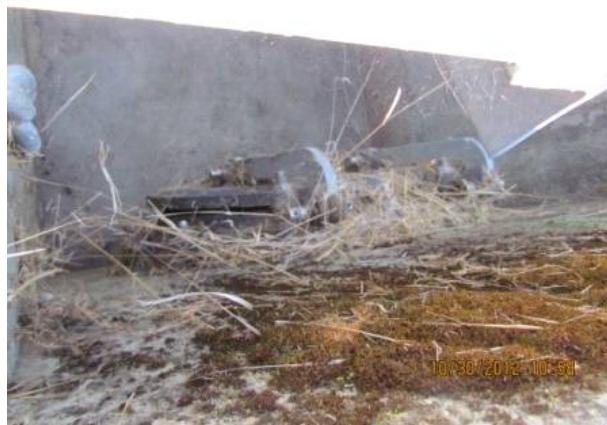
-121.442203 °	-121.442203 °	Y	DWR ID: DWR_NA0001_01_s_2012_35
29	1.58	1.58	Earthen Levee	Encroachments	WSA/W Ma	PI	DE : Pipe Inspector Comments: Flap gate appeared to be closed.	38.627244 °	38.627244 °	174	
								-121.441462 °	-121.441462 °	Y	DWR ID: DWR_NA0001_01_s_2012_174
30	1.58	1.58	Earthen Levee	Slope Stability	LS Ma	A/W	S2 : Repair the levee slope damaged by foot traffic and prevent access where possible.	38.627251 °	38.627251 °	54	
								-121.441460 °	-121.441460 °	Y	DWR ID: DWR_NA0001_01_s_2012_54
31	1.59	1.59	Earthen Levee	Trim / Thin Trees	LS Ma	N	T5 : Tree stumps.	38.627335 °	38.627335 °	31	
								-121.441172 °	-121.441172 °	Y	DWR ID: DWR_NA0001_01_f_2012_31
32	1.59	1.59	Earthen Levee	Encroachments	LS En	M	DE : Debris Inspector Comments: Wood rounds and some pieces of pipe may be being stored on levee, need to be removed.	38.627215 °	38.627215 °	37	
								-121.441218 °	-121.441218 °	Y	DWR ID: DWR_NA0001_01_s_2012_37

Levee Mile Report Line	29
Start Levee Mile	1.58
End Levee Mile	1.58
Location	Water Side
Category	Earthen Levee
Item	Encroachments
View of flap gate.	
mkhashch_f_20130923_856.JPG

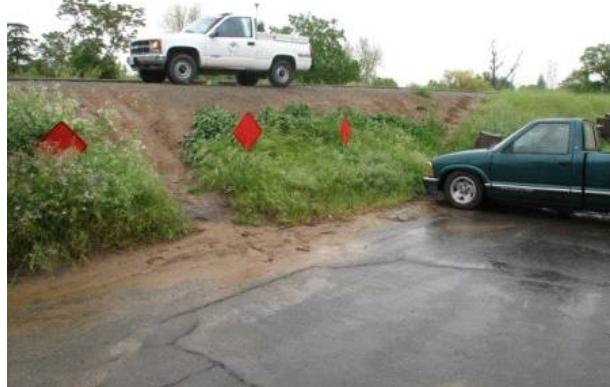
Levee Mile Report Line	30
Start Levee Mile	1.58
End Levee Mile	1.58
Location	Land Side
Category	Earthen Levee
Item	Slope Stability
Slope stability due to foot traffic needs to be monitored.	
mkhashch_f_20130923_846.jpg

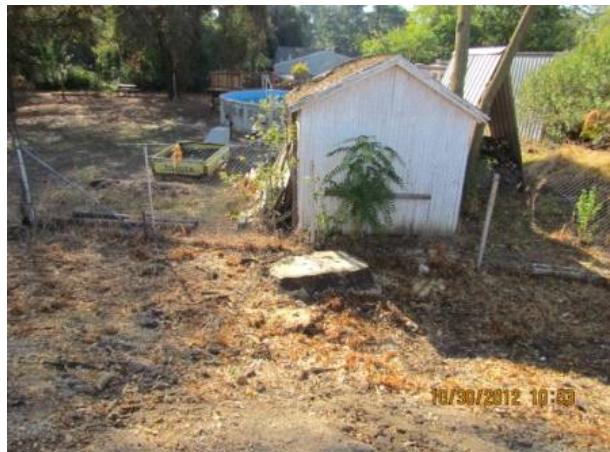
Levee Mile Report Line	31
Start Levee Mile	1.59
End Levee Mile	1.59
Location	Land Side
Category	Earthen Levee
Item	Trim / Thin Trees
View of large tree stump at levee toe.	
mkhashch_f_20130923_841.JPG

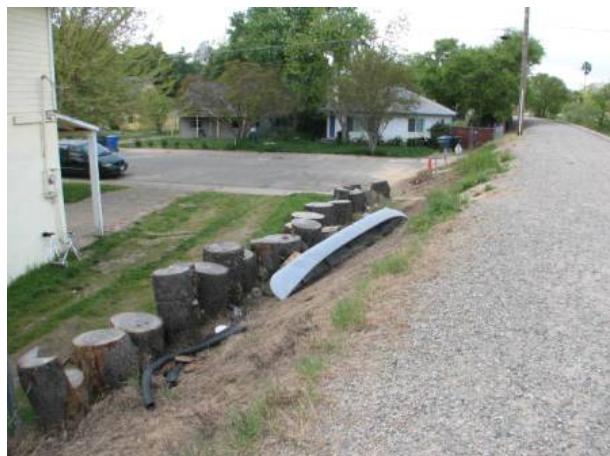
Levee Mile Report Line	32
Start Levee Mile	1.59
End Levee Mile	1.59
Location	Land Side
Category	Earthen Levee
Item	Encroachments
04/13/2011 Items appear to be stored on levee, need to be removed.	
mkhashch_f_20130923_844.jpg

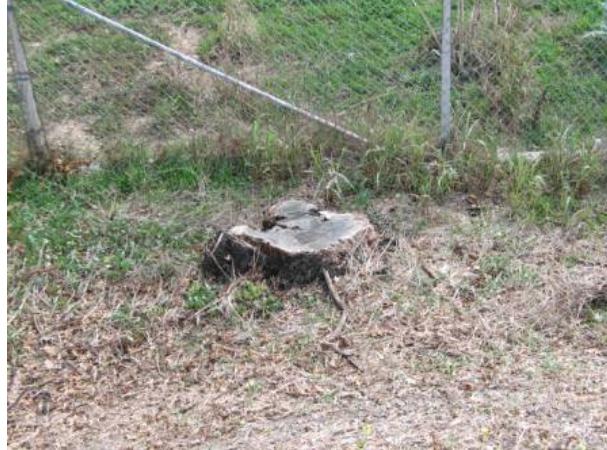
33	1.65	1.65	Earthen Levee	Trim / Thin Trees	LS Ma	N	T5 : Tree stumps. Inspector Comments: Large stump at levee toe.	38.627289 °	38.627289 °	173	
								-121.440185 °	-121.440185 °	Y	DWR ID: DWR_NA0001_01_s_2012_173
34	1.78	1.78	Earthen Levee	Encroachments	LS En	U	FE : Fence Inspector Comments: New fence constructed with 7 redwood planted at levee toe.	38.627945 °	38.627945 °	10	
								-121.437903 °	-121.437903 °	Y	DWR ID: DWR_NA0001_01_f_2012_10
35	1.81	1.81	Earthen Levee	Vegetation	LS En	U	V6 : Landscaping Inspector Comments: Growth on old wooden fence, which has since been replaced by a chainlink fence is obstructive.	38.627934 °	38.627934 °	170	
								-121.437423 °	-121.437423 °	Y	DWR ID: DWR_NA0001_01_s_2012_170
36	1.82	1.82	Earthen Levee	Encroachments	LS En	U	BU : Building Inspector Comments: Shed on concrete pad within 10' of the levee toe.	38.627914 °	38.627914 °	169	
								-121.437263 °	-121.437263 °	Y	DWR ID: DWR_NA0001_01_s_2012_169

Levee Mile Report Line	33
Start Levee Mile	1.65
End Levee Mile	1.65
Location	Land Side
Category	Earthen Levee
Item	Trim / Thin Trees
11/17/2011 Stump at levee toe.	
mkhashch_f_20130923_855.jpg

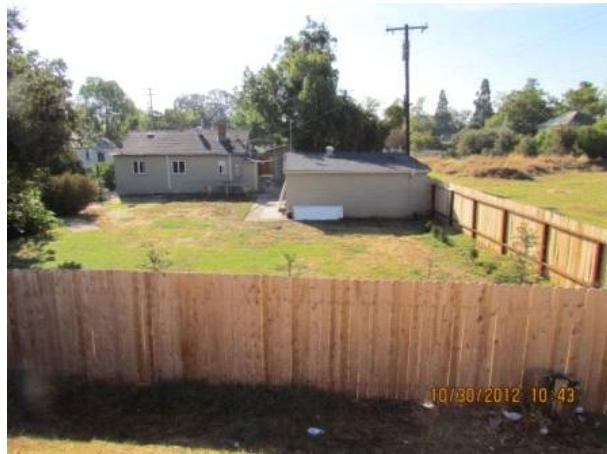
Levee Mile Report Line	34
Start Levee Mile	1.78
End Levee Mile	1.78
Location	Land Side
Category	Earthen Levee
Item	Encroachments
View of new fence constructed at levee toe and 7 redwood trees planted behind fence within easement.	
mkhashch_f_20130923_825.JPG

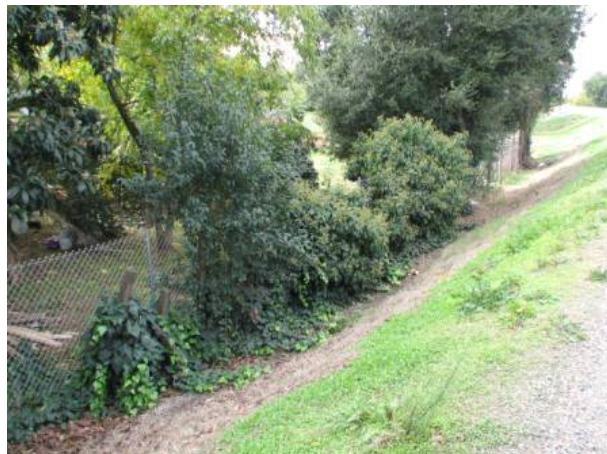
Levee Mile Report Line	35
Start Levee Mile	1.81
End Levee Mile	1.81
Location	Land Side
Category	Earthen Levee
Item	Vegetation
11/17/2011 Growth on existing wooden fence is obstructive.	
mkhashch_f_20130923_854.jpg

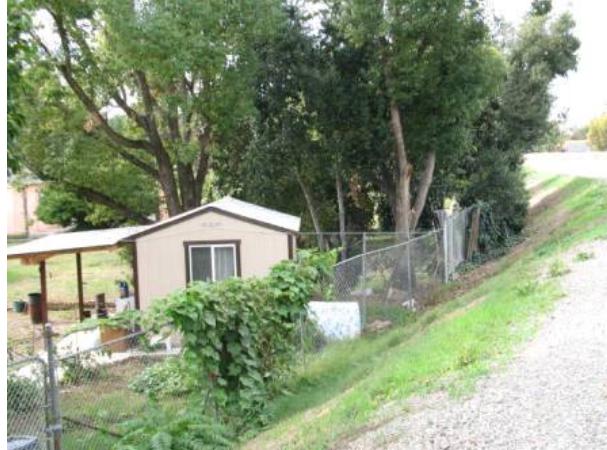
Levee Mile Report Line	36
Start Levee Mile	1.82
End Levee Mile	1.82
Location	Land Side
Category	Earthen Levee
Item	Encroachments
11/17/2011 Wooden shed on concrete pad built within 15' of levee toe.	
mkhashch_f_20130923_853.jpg

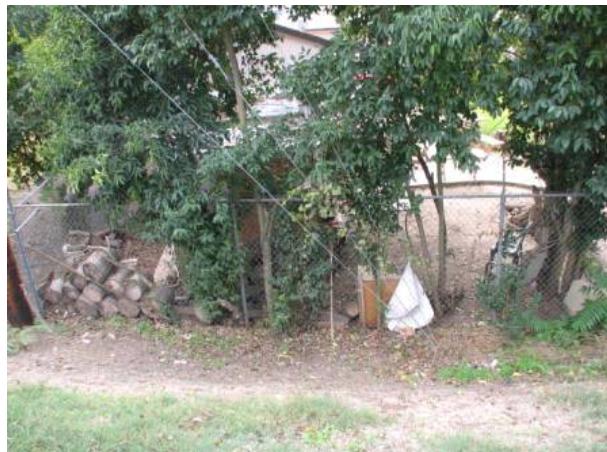
Levee Mile Report Line	37
Start Levee Mile	1.82
End Levee Mile	1.82
Location	Land Side
Category	Earthen Levee
Item	Encroachments
11/17/2011 Wooden structure is built within 15' of the levee toe.	
mkhashch_f_20130923_842.jpg

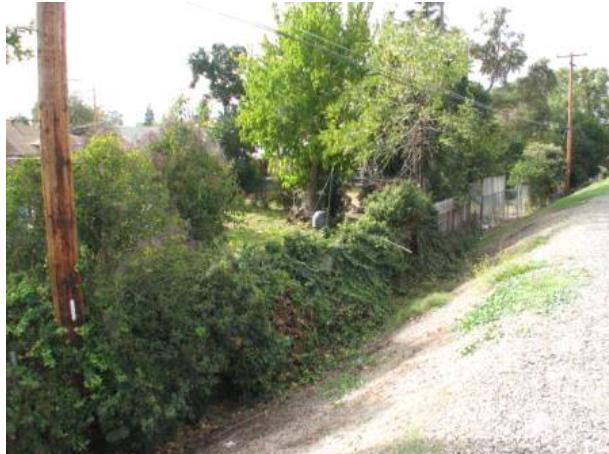
Levee Mile Report Line	39
Start Levee Mile	1.87
End Levee Mile	1.87
Location	Land Side
Category	Earthen Levee
Item	Vegetation
11/17/2011 Landscaping vegetation growth on the fence is obstructive.	
mkhashch_f_20130923_823.jpg

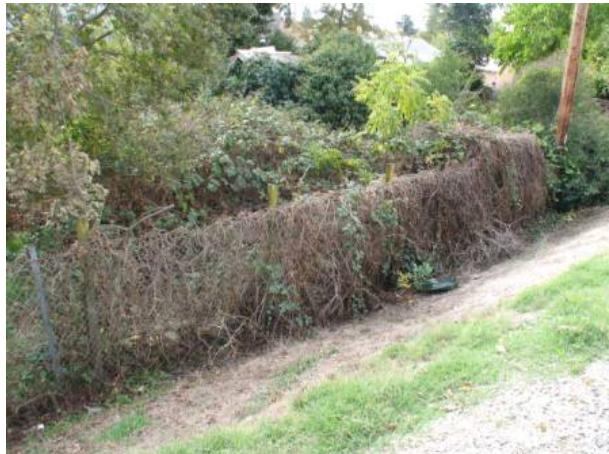
Levee Mile Report Line	40
Start Levee Mile	1.88
End Levee Mile	1.88
Location	Land Side
Category	Earthen Levee
Item	Vegetation
11/17/2011 Blackberries growing on fence are obstructive.	
mkhashch_f_20130923_822.jpg

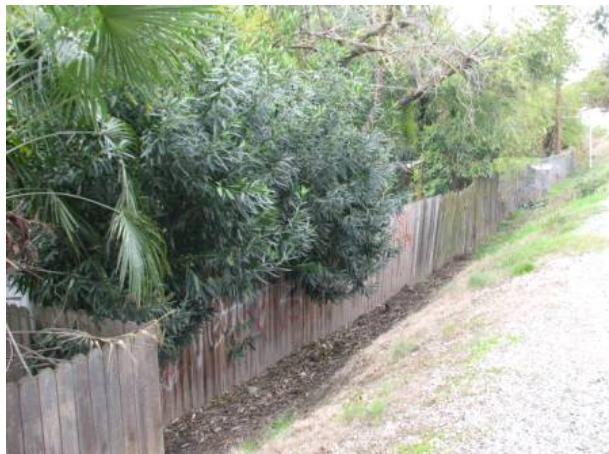
Levee Mile Report Line	41
Start Levee Mile	1.92
End Levee Mile	1.92
Location	Land Side
Category	Earthen Levee
Item	Encroachments
11/17/2011 Wooden privacy fence built at the levee toe.	
mkhashch_f_20130923_821.jpg

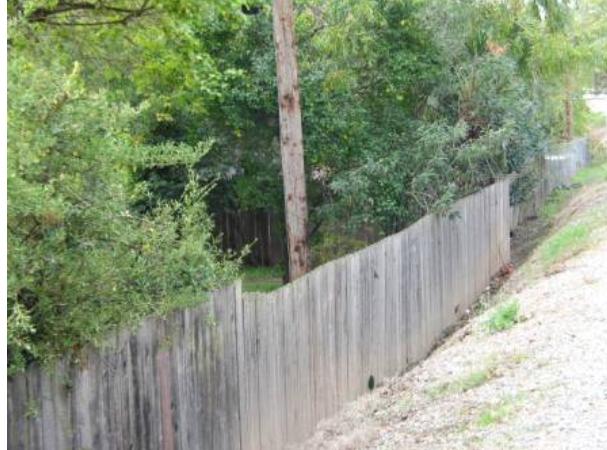
Levee Mile Report Line	42
Start Levee Mile	1.93
End Levee Mile	1.93
Location	Land Side
Category	Earthen Levee
Item	Encroachments
11/17/2011 Wooden privacy fence built at the levee toe.	
mkhashch_f_20130923_820.jpg

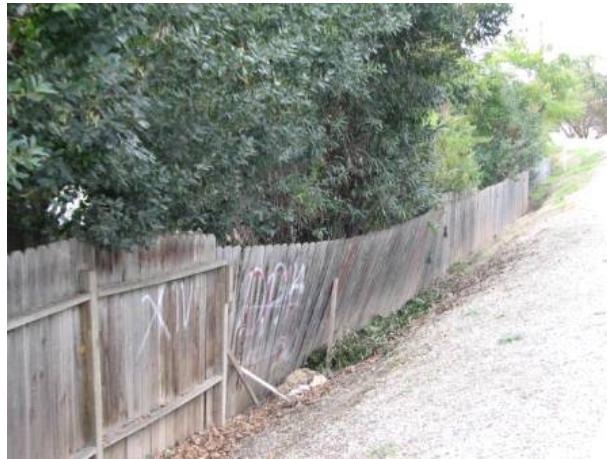
Levee Mile Report Line	43
Start Levee Mile	1.94
End Levee Mile	1.94
Location	Land Side
Category	Earthen Levee
Item	Encroachments
11/17/2011 Wooden privacy fence built at the levee toe.	
mkhashch_f_20130923_819.jpg

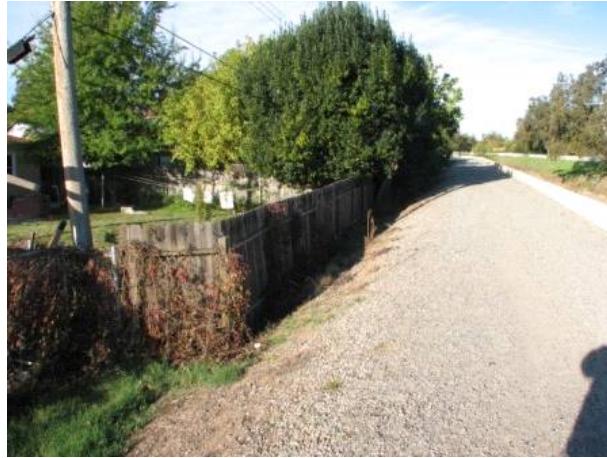
Levee Mile Report Line	44
Start Levee Mile	1.95
End Levee Mile	1.95
Location	Land Side
Category	Earthen Levee
Item	Encroachments
Fall 2009 photo: Wooden fence built on levee slope.	
mkhashch_f_20130923_818.jpg

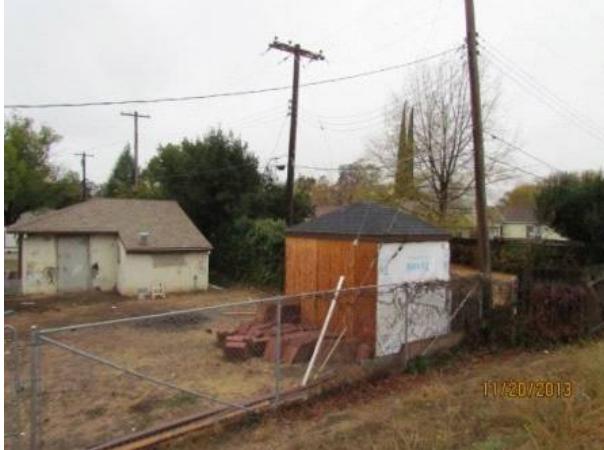
Levee Mile Report Line	45
Start Levee Mile	1.95
End Levee Mile	1.95
Location	Land Side
Category	Earthen Levee
Item	Encroachments
Building on concrete pad being built within 15' of the levee toe.	
mkhashch_f_20131120_740.JPG

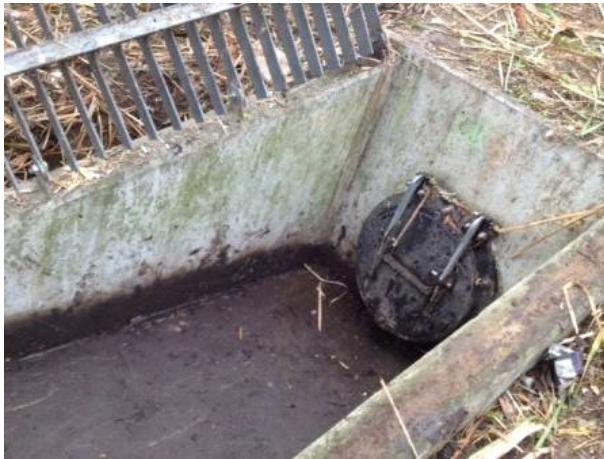
Levee Mile Report Line	46
Start Levee Mile	1.95
End Levee Mile	1.95
Location	Water Side
Category	Earthen Levee
Item	Encroachments
View of properly closed flap gate.	
mkhashch_f_20130923_852.jpg

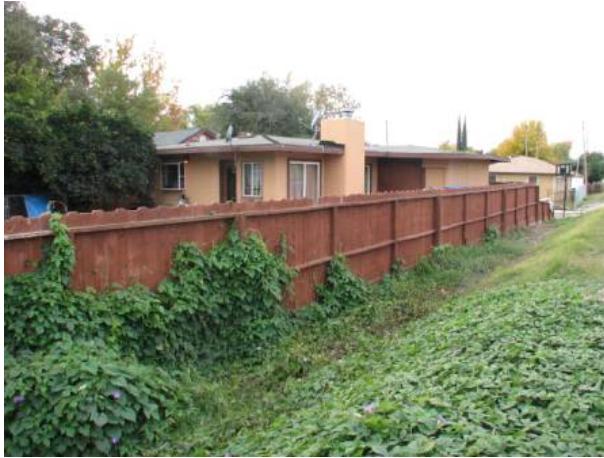
Levee Mile Report Line	47
Start Levee Mile	1.98
End Levee Mile	1.98
Location	Land Side
Category	Earthen Levee
Item	Encroachments
11/17/2011 Wooden privacy fence built at the levee toe.	
mkhashch_f_20130923_851.jpg

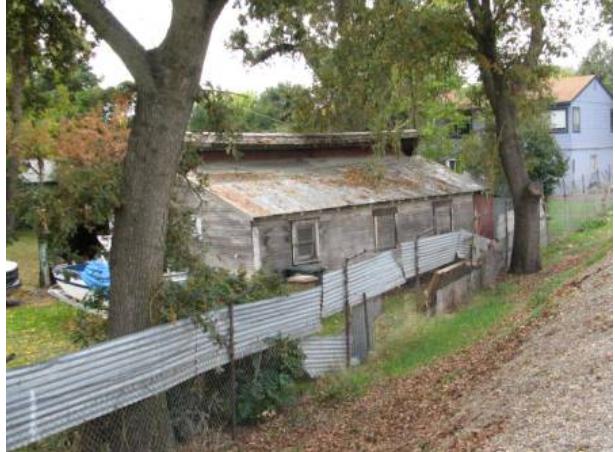
mhashch_f_20130923_838.jpg

Levee Mile Report Line	50
Start Levee Mile	2.04
End Levee Mile	2.04
Location	Land Side
Category	Earthen Levee
Item	Encroachments
11/17/2011 Wooden structure is within 15' of the levee toe.

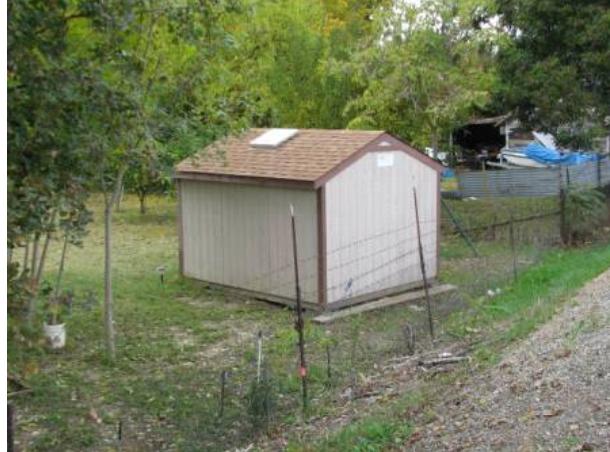
Levee Mile Report Line	51
Start Levee Mile	2.05
End Levee Mile	2.05
Location	Land Side
Category	Earthen Levee
Item	Encroachments
11/17/2011 Wooden structure is within 15' of the levee toe.	
mkhashch_f_20130923_837.jpg

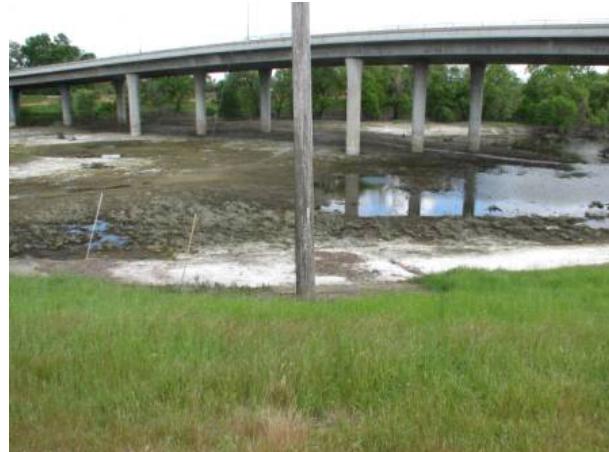
Levee Mile Report Line	1
Start Levee Mile	0.28
End Levee Mile	0.28
Location	Water Side
Category	Earthen Levee
Item	Encroachments
04/13/2011 Power pole is in the levee on the water side.	
mhashch_f_20130923_862.jpg

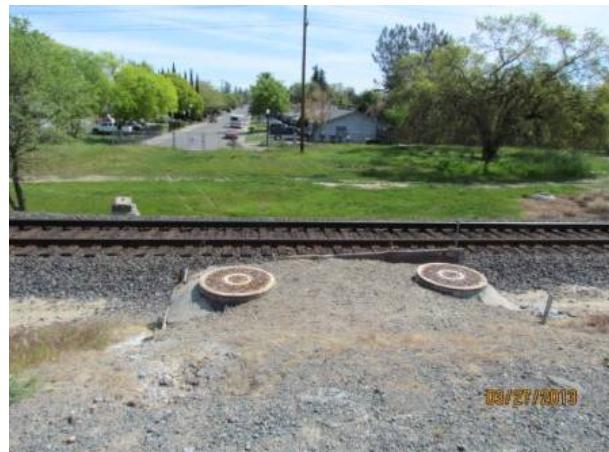
Levee Mile Report Line	2
Start Levee Mile	0.77
End Levee Mile	0.77
Location	Crown
Category	Earthen Levee
Item	Encroachments
View of the pipe access at the landside levee hinge.	
mhashch_f_20130923_864.JPG

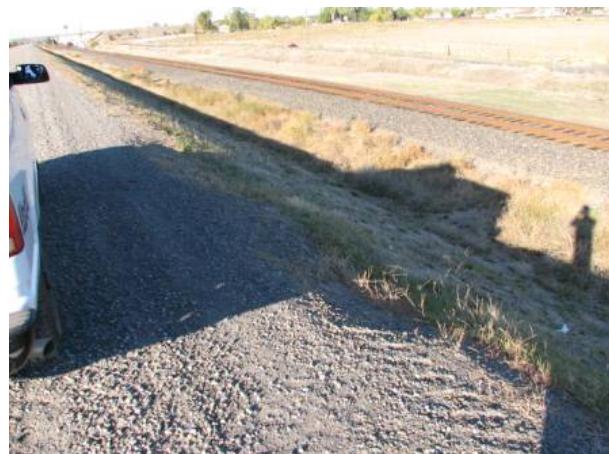
Levee Mile Report Line	5
Start Levee Mile	2.33
End Levee Mile	2.33
Location	Land Side
Category	Earthen Levee
Item	Erosion / Bank Caving
11/16/2011 Depressions present on levee slope.	
mhashch_f_20130923_865.jpg

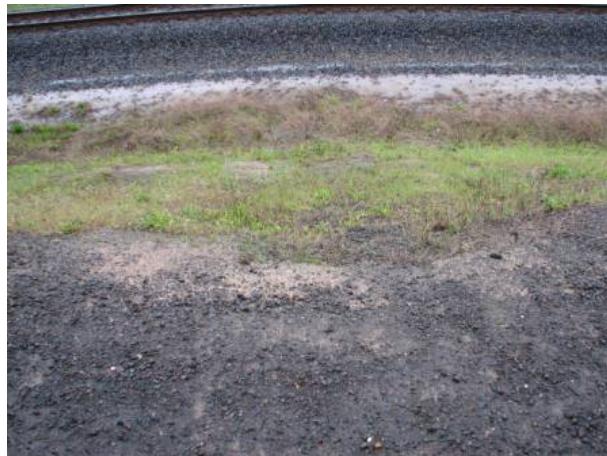
Levee Mile Report Line	5
Start Levee Mile	2.33
End Levee Mile	2.33
Location	Land Side
Category	Earthen Levee
Item	Erosion / Bank Caving
03/14/2012 Photo shows depression, the issue has not gotten any worse since the fall 2011 inspection.	
mkhashch_f_20130923_866.jpg

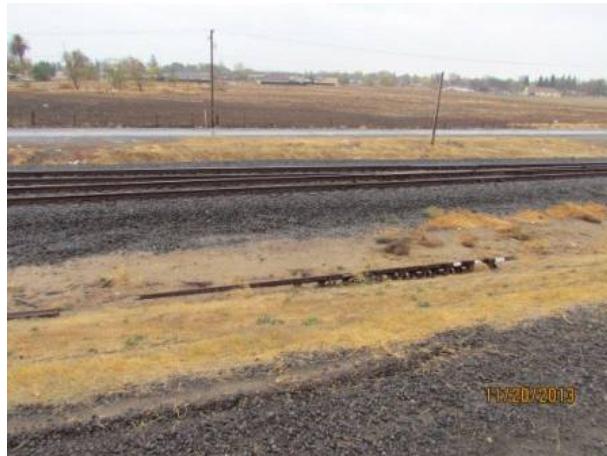
Levee Mile Report Line	6
Start Levee Mile	2.52
End Levee Mile	2.52
Location	Land Side
Category	Earthen Levee
Item	Encroachments
View of the rails at the landside levee toe.	
mkhashch_f_20131120_731.JPG

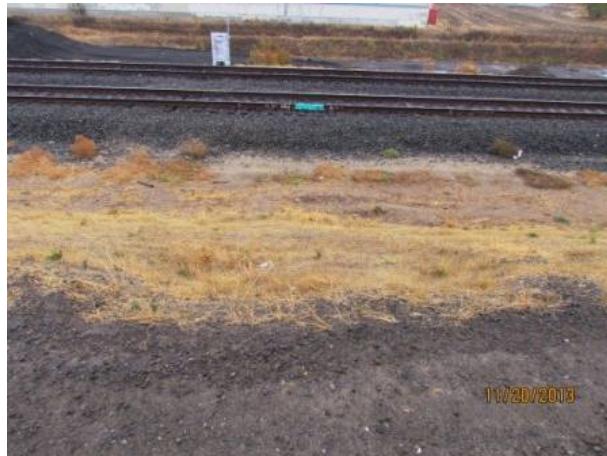
Levee Mile Report Line	7
Start Levee Mile	2.92
End Levee Mile	2.92
Location	Land Side
Category	Earthen Levee
Item	Slope Stability
View of landside slope instability.	
mkhashch_f_20131120_730.JPG

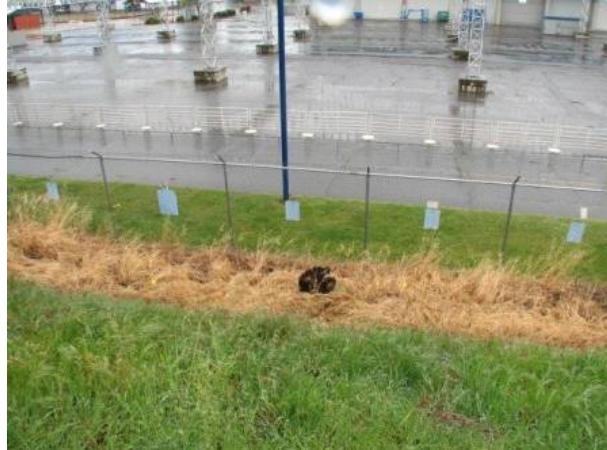
Levee Mile Report Line	1
Start Levee Mile	0.74
End Levee Mile	0.74
Location	Land Side
Category	Earthen Levee
Item	Trim / Thin Trees
Tree stump on levee slope greater than 2" Dia.	
mkhashch_f_20130923_868.jpg

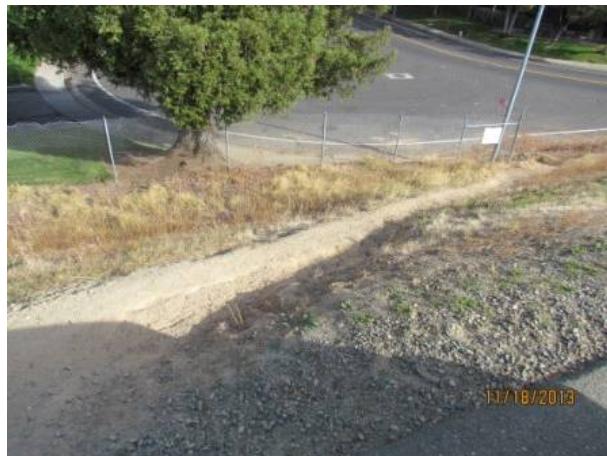
Levee Mile Report Line	3
Start Levee Mile	1.80
End Levee Mile	1.80
Location	Land Side
Category	Earthen Levee
Item	Slope Stability
View of the erosion on landside levee slope due to pedestrian traffic.	
mkhashch_f_20131120_712.JPG

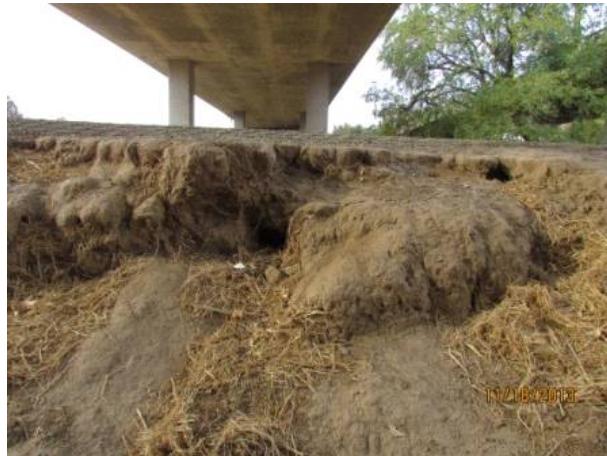
Levee Mile Report Line	6
Start Levee Mile	3.14
End Levee Mile	3.14
Location	Land Side
Category	Earthen Levee
Item	Animal Control
View of the rodent holes on the landside levee slope.	
mkhashch_f_20131120_711.JPG

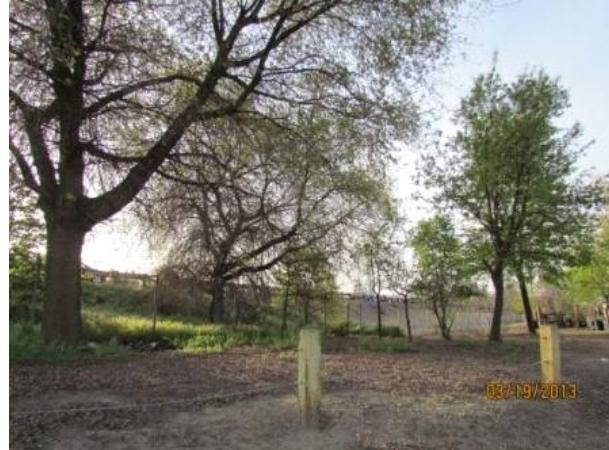
mkhashch_f_20130923_029.JPG

View of the landscaping on levee crown.

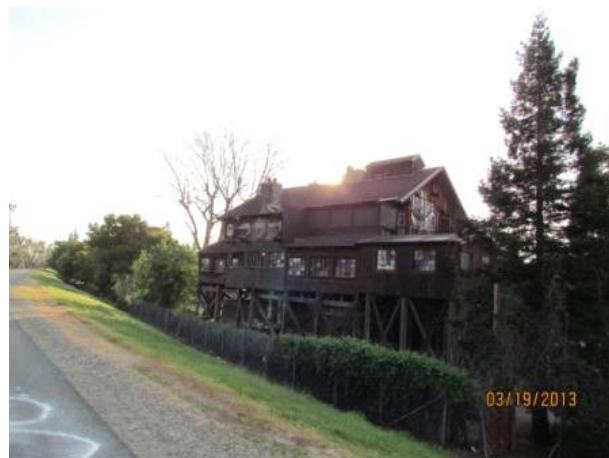
Levee Mile Report Line	2
Start Levee Mile	0.32
End Levee Mile	0.46
Location	Land Side
Category	Earthen Levee
Item	Vegetation

View of the vines obstructing visibility.

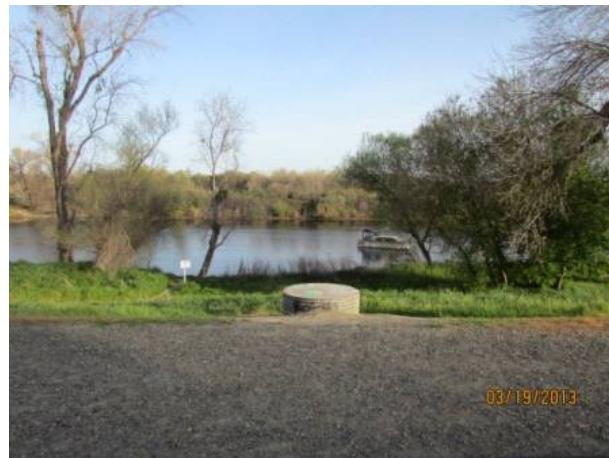
Levee Mile Report Line	3
Start Levee Mile	0.41
End Levee Mile	0.41
Location	Crown
Category	Earthen Levee
Item	Encroachments

View of the abandoned pipe.

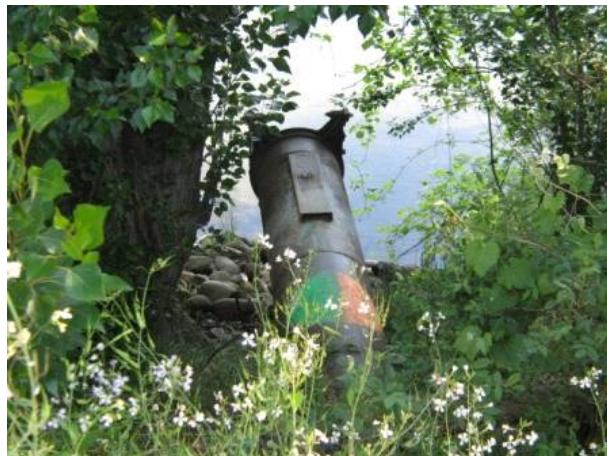
Levee Mile Report Line	6
Start Levee Mile	0.94
End Levee Mile	0.94
Location	Crown
Category	Earthen Levee
Item	Encroachments
Discharge pipe from printing shop into American River.	
mhashch_f_20130923_059.jpg

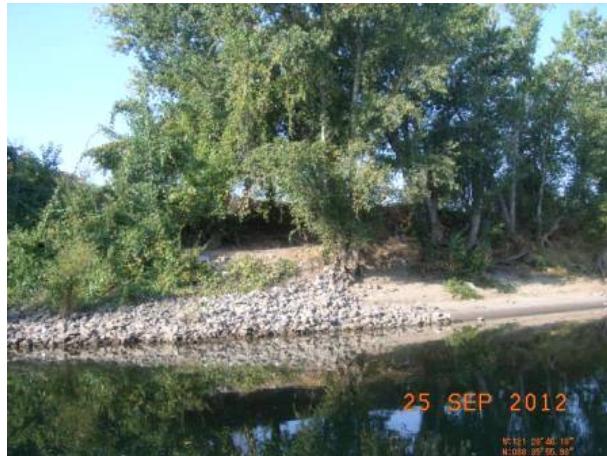
Levee Mile Report Line	7
Start Levee Mile	1.62
End Levee Mile	1.62
Location	Water Side
Category	Supplemental
Item	USACE Erosion Survey
USACE 2012 Photo #1	
USACE2013_LAR_1-8_L_1.jpg

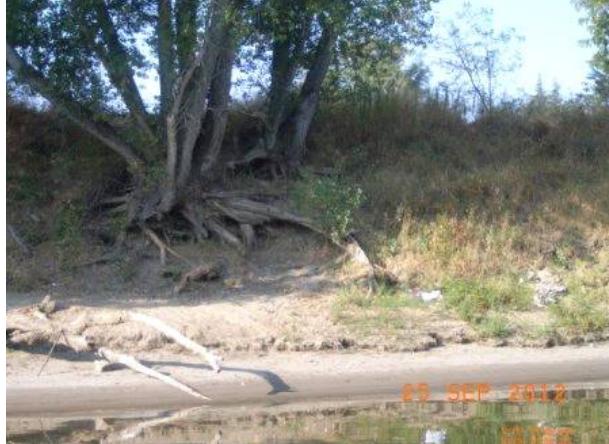
USACE 2012 Photo #2

Levee Mile Report Line	7
Start Levee Mile	1.62
End Levee Mile	1.62
Location	Water Side
Category	Supplemental
Item	USACE Erosion Survey

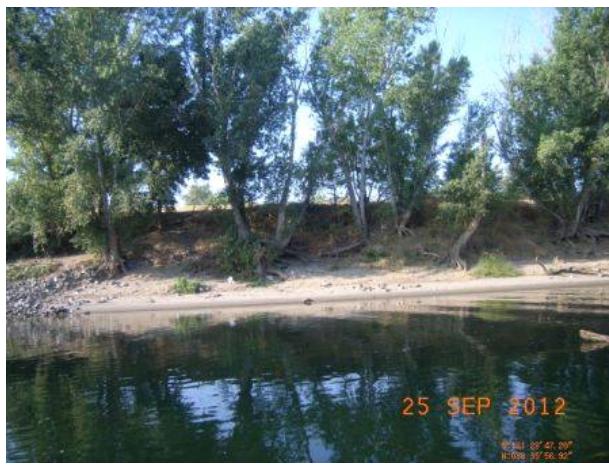
USACE 2012 Photo #3

Levee Mile Report Line	7
Start Levee Mile	1.62
End Levee Mile	1.62
Location	Water Side
Category	Supplemental
Item	USACE Erosion Survey

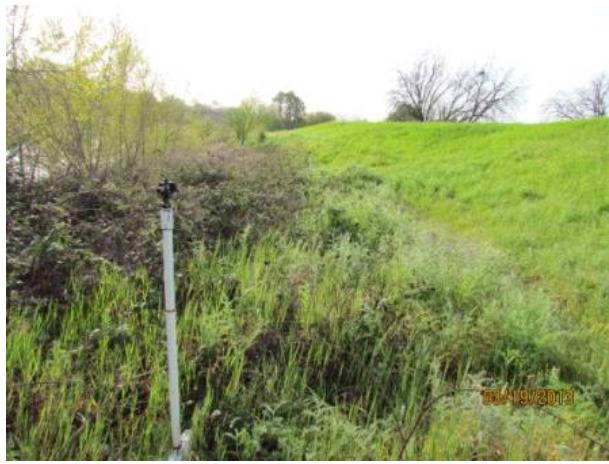
Levee Mile Report Line	8
Start Levee Mile	1.69
End Levee Mile	1.78
Location	Water Side
Category	Earthen Levee
Item	Encroachments

View of the irrigation system along the levee on waterside slope.

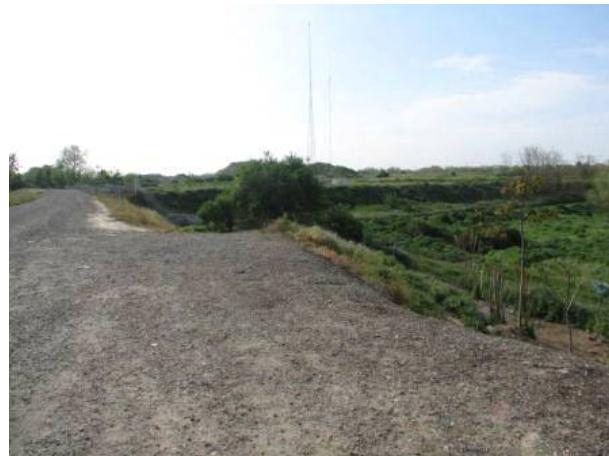
Levee Mile Report Line	10
Start Levee Mile	2.50
End Levee Mile	2.50
Location	Land Side
Category	Earthen Levee
Item	Vegetation
04/14/2011 Elderberry bush prevents visibility of levee toe.	
mkhashch_f_20130923_035.jpg

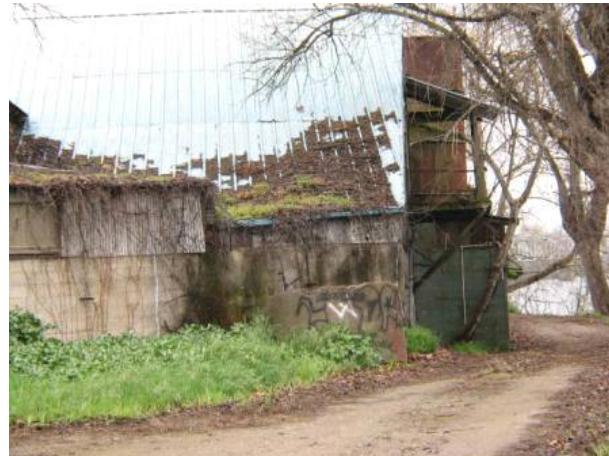
Levee Mile Report Line	11
Start Levee Mile	2.68
End Levee Mile	2.68
Location	Land Side
Category	Earthen Levee
Item	Encroachments
03/16/2012 Structure on Bell Marine property.	
mkhashch_f_20130923_871.jpg

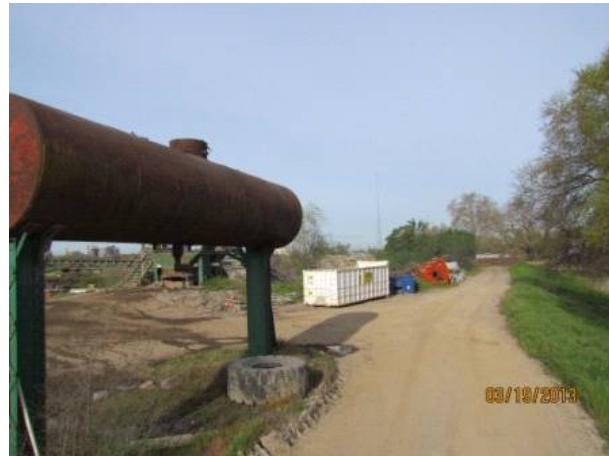
Levee Mile Report Line	12
Start Levee Mile	2.73
End Levee Mile	2.86
Location	Land Side
Category	Earthen Levee
Item	Encroachments
View of the debris obstructing visibility and access.	
mkhashch_f_20130923_872.JPG

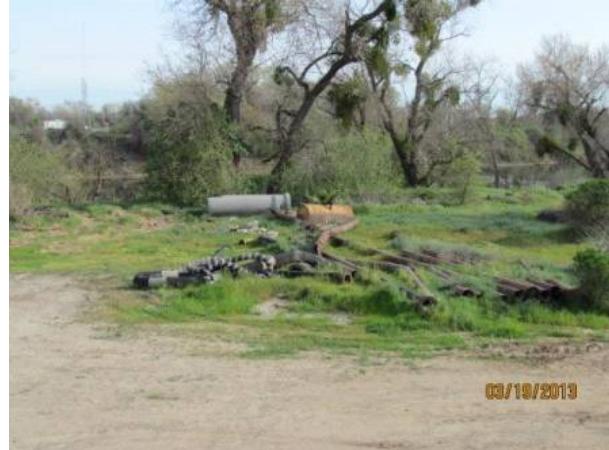
mkhashch_f_20130923_873.JPG

View of the debris stored in floodway.

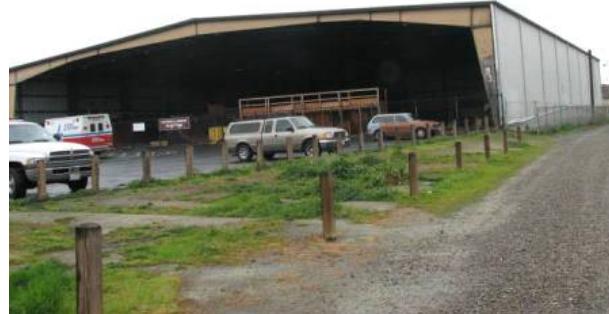
Levee Mile Report Line	16
Start Levee Mile	2.92
End Levee Mile	2.96
Location	Land Side
Category	Earthen Levee
Item	Encroachments

03/16/2012 Sutter's Landing Skate Park.

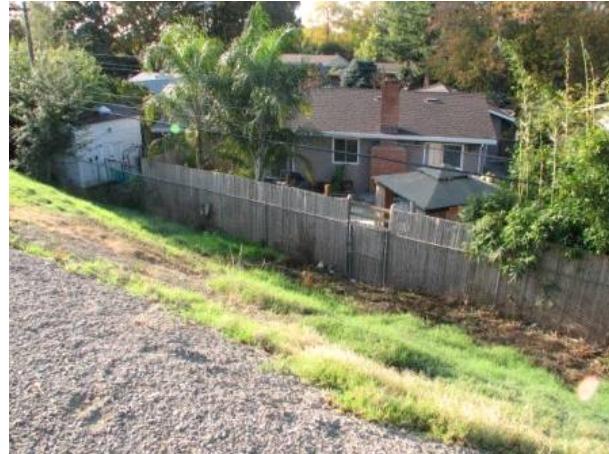
Levee Mile Report Line	18
Start Levee Mile	3.88
End Levee Mile	3.88
Location	Land Side
Category	Earthen Levee
Item	Encroachments

Fall 2009 photo: Fence and landscaping within 10-ft of levee toe obstructs access and visibility.

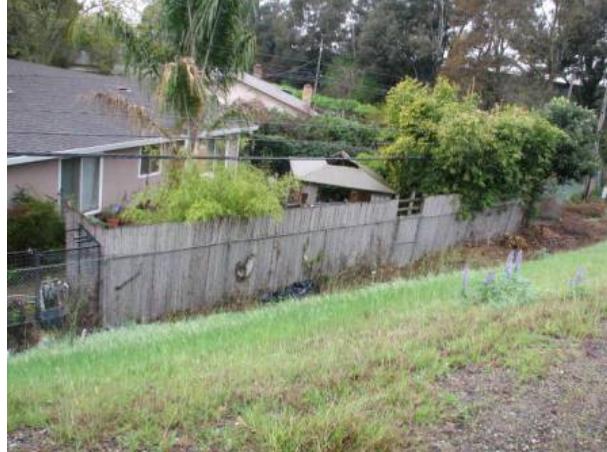
Levee Mile Report Line	18
Start Levee Mile	3.88
End Levee Mile	3.88
Location	Land Side
Category	Earthen Levee
Item	Encroachments
03/16/2012 Wood privacy fence completely obstructs access and visibility.	
mkhashch_f_20130923_880.jpg

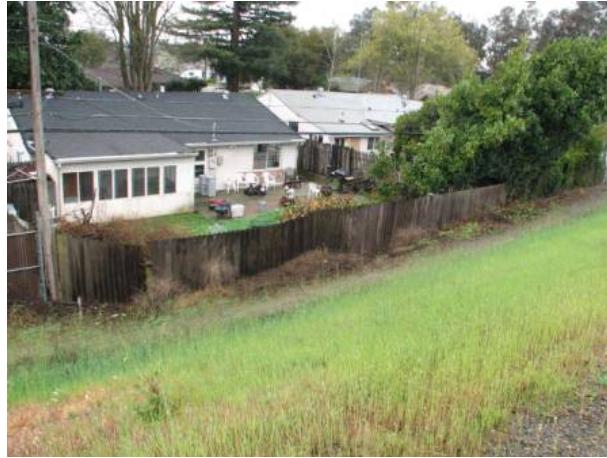
Levee Mile Report Line	20
Start Levee Mile	3.91
End Levee Mile	3.91
Location	Land Side
Category	Earthen Levee
Item	Encroachments
03/16/2012 Wood privacy fence completely obstructs access and visibility.	
mkhashch_f_20130923_881.jpg

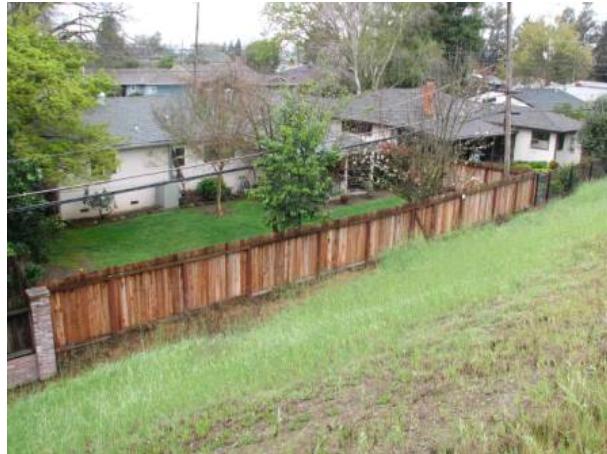
Levee Mile Report Line	21
Start Levee Mile	3.95
End Levee Mile	3.95
Location	Land Side
Category	Earthen Levee
Item	Encroachments
03/16/2012 Wood privacy fence completely obstructs access and visibility.	
mkhashch_f_20130923_883.jpg

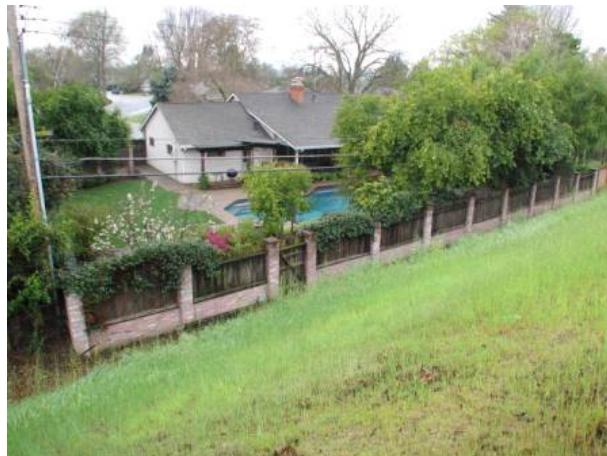
Levee Mile Report Line	22
Start Levee Mile	3.96
End Levee Mile	3.96
Location	Land Side
Category	Earthen Levee
Item	Encroachments
03/16/2012 Wood privacy fence completely obstructs access and visibility.	
mkhashch_f_20130923_884.jpg

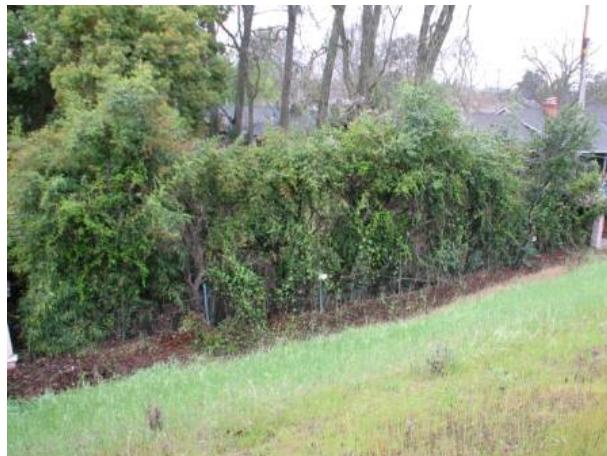
Levee Mile Report Line	23
Start Levee Mile	3.97
End Levee Mile	3.97
Location	Land Side
Category	Earthen Levee
Item	Vegetation
03/16/2012 Landscape obstructs visibility and access.	
mkhashch_f_20130923_966.jpg

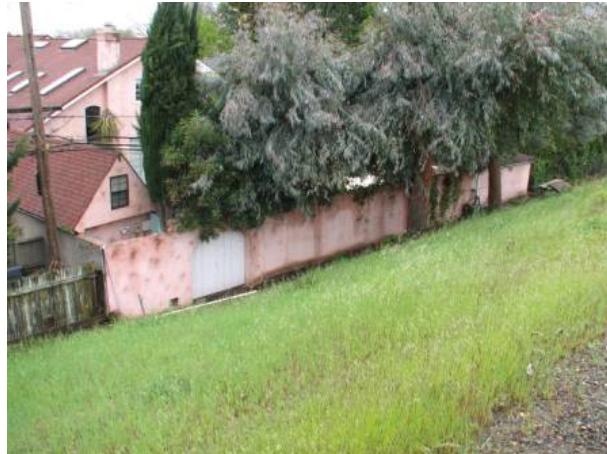
Levee Mile Report Line	24
Start Levee Mile	3.98
End Levee Mile	3.98
Location	Land Side
Category	Earthen Levee
Item	Encroachments
03/16/2012 Concrete wall obstructs access and visibility.	
mkhashch_f_20130923_885.jpg

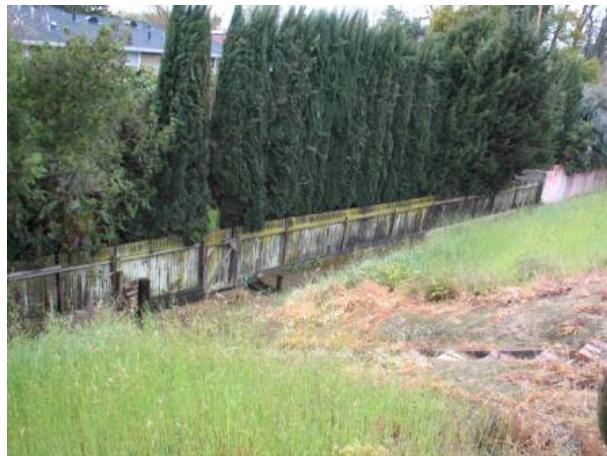
Levee Mile Report Line	25
Start Levee Mile	4.00
End Levee Mile	4.00
Location	Land Side
Category	Earthen Levee
Item	Encroachments
03/16/2012 Wood privacy fence completely obstructs access and visibility.	
mkhashch_f_20130923_886.jpg

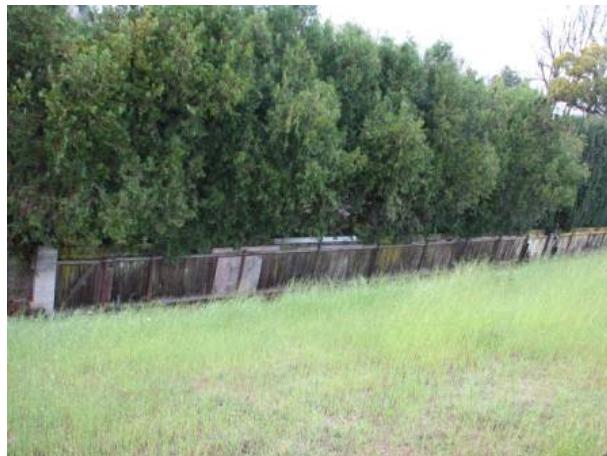
Levee Mile Report Line	26
Start Levee Mile	4.01
End Levee Mile	4.01
Location	Land Side
Category	Earthen Levee
Item	Encroachments
03/16/2012 Wood privacy fence completely obstructs access and visibility.	
mkhashch_f_20130923_887.jpg
